Area and Department Information

After Action Review

5120 Hill Rd. Incident Timeline

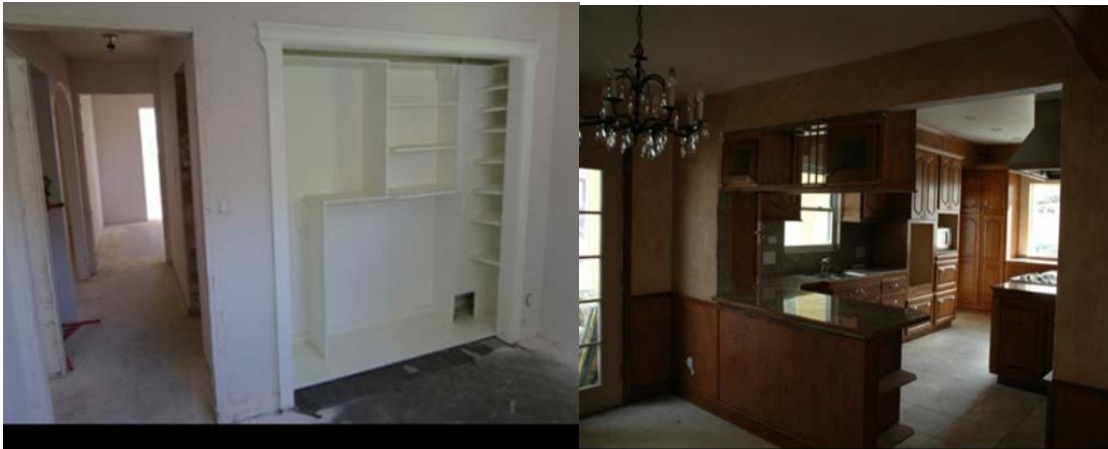
Interior pictures:

The E16 captain's recognition of the exposed wall studs and second floor TGI trusses once the garage was opened up was noteworthy, but did not seem like a critical issue. Two weeks earlier, this house was for sale online with numerous photos of the interior, including the garage area. Once he noticed the exposed studs in the garage during the incident, he believed this was just a small area still yet to be sheet rocked from the recent renovation. Situational awareness is only as good as one's perception accurately matching reality or, in this case, wishful thinking matching reality. What the E16 captain didn't know was that the structure had been vandalized two days prior. Someone had plugged drains, turned on the water, and flooded the home. A restoration company had just removed a lot of the sheetrock throughout the structure, to aid in the drying of the wood. This provided incredible flow paths for the wind driven event.

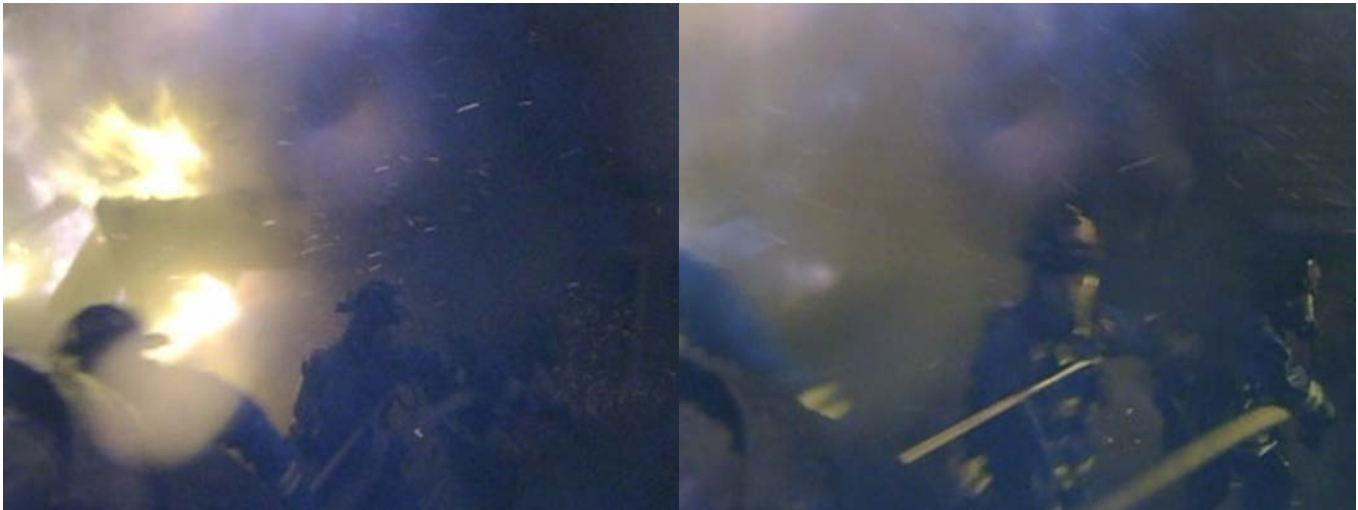
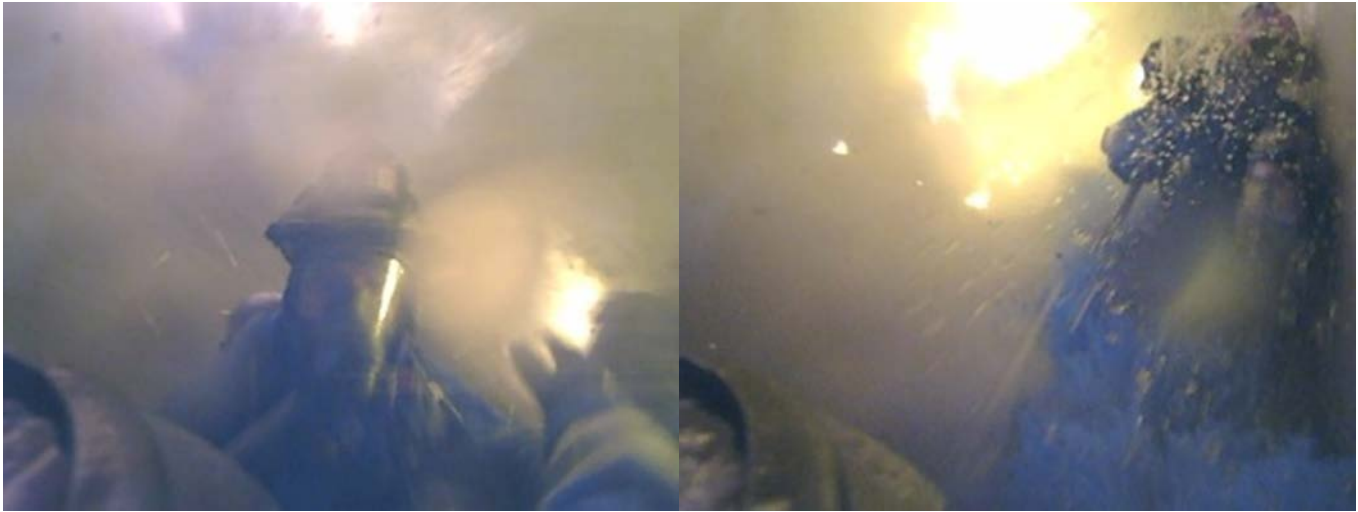
The E-9 captain advised that he reported the imminent collapse when he witnessed bare studs on the Charlie side cracking. Furthermore, he stated that he had never seen a similar collapse in his 25 years on the job. He expected an eventual collapse, but thought it would occur locally, not globally. Fortunately, he was in a position to observe collapse indicators and report them prior to when it occurred.
