Area and Department Information

After Action Review

5120 Hill Rd. Incident Timeline

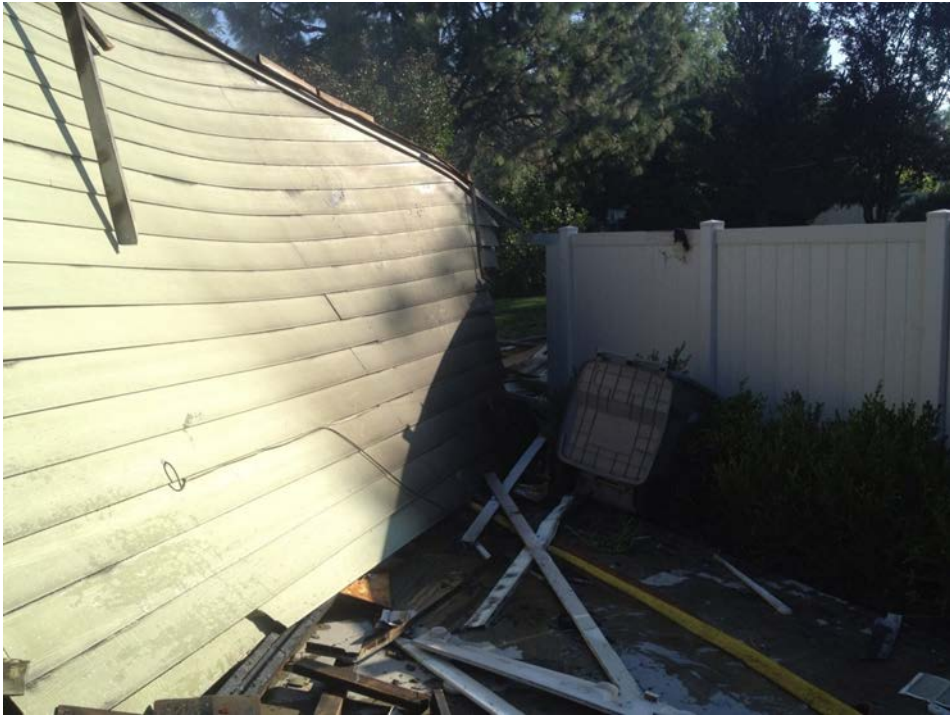
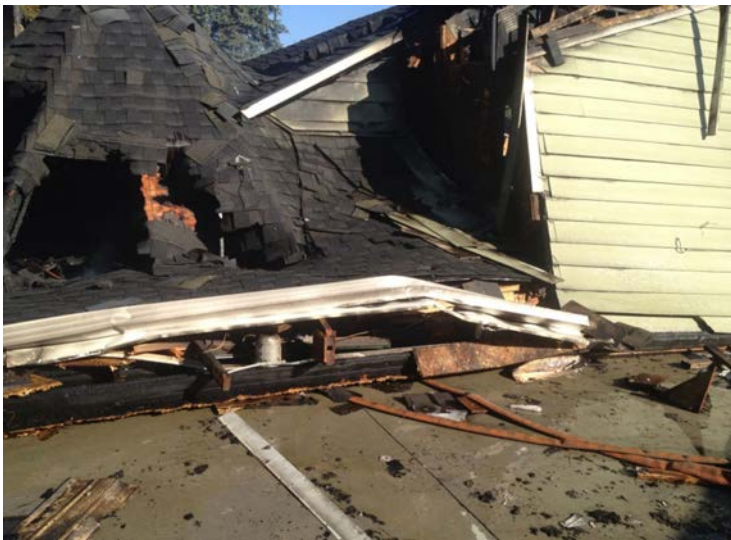
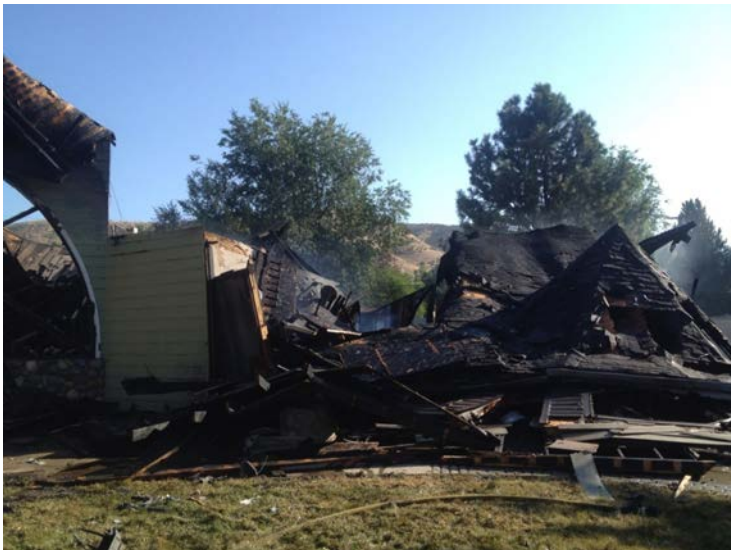
Both E9 and E16’s hoselines were found beneath the collapsed structure. BC2 stated that he expected collapse at some point, but did not expect it to occur so quickly or so globally. Crews operating on the Delta side were unaware of the advanced fire conditions in the rest of the structure, believing that the fire was isolated to where they were making their attack. Crews operating on the Delta side were also unaware of a master stream being placed into operation. From the IC’s location (dash cam), he did not realize crews on Delta were operating so near the structure when he gave the okay for the E9 driver to flow it. In hindsight, the IC indicated that he should have requested a tone alert and announced to all crews operating on the fireground that a master stream would be going into operation. Three firefighters were injured (back, head, ribs) during the collapse, but none were transported to the hospital.
